On-Site Ambulance Investigation
SCI Case No.: DS11018
Vehicle: 2007 Ford E-350 Ambulance
Location: California
Incident Date: May 2011

1. Report No. DS11018		2. Government Accession No.		3. Recipient Catalog No.	
4. Title and Subtitle On-Site Ambulance Investigation Vehicle: 2007 Ford E-350 Ambulance Location: California Incident Date: May 2011				5. Report Date January 6, 2012

BACKGROUND

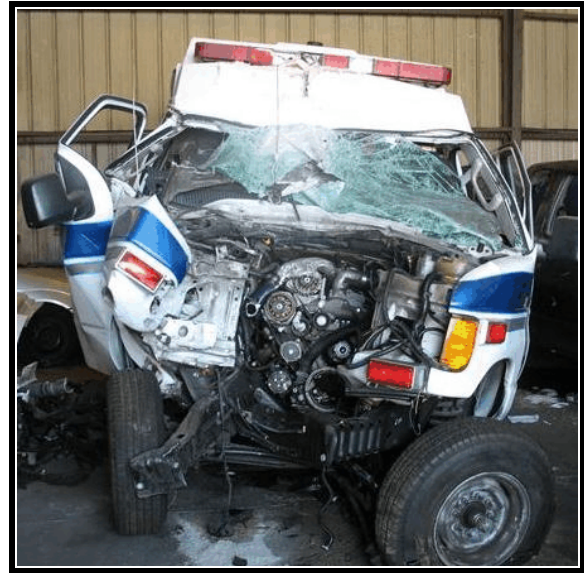
This on-site investigation focused on the crash dynamics and injuries sustained in a crash involving a 2007 Ford E350 Econoline van that was configured as a Type II¹ ambulance (**Figure 1**). The crash occurred on a westbound interstate highway in May 2011 at 0605 hours.

Figure 1. 2007 Ford E350 ambulance

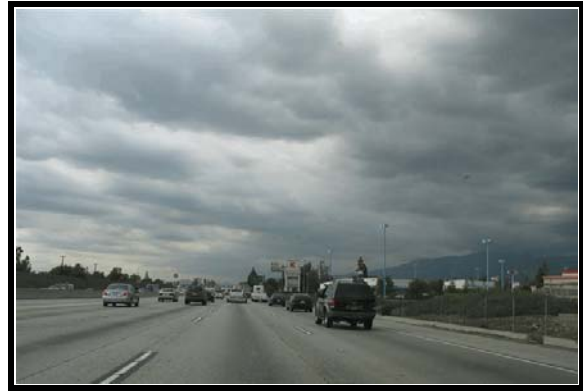
This crash occurred alongside a westbound 5-lane, divided interstate roadway (**Figure 2**). The roadway was separated from eastbound traffic by a concrete median wall. The first travel lane from the left was a High Occupancy Vehicle (HOV) lane that was separated on the left by an asphalt shoulder and separated from the adjacent travel lane by painted yellow lines. The four travel lanes were separated from each other by white painted lines. To the right of the northernmost lane, there was a 3.0 m (10.0 ft) concrete shoulder, a wood/metal guardrail, a 1.2 m (4.0 ft) concrete drainage ditch, and a chain link fence. A 60.0 cm (23.6 in) diameter metal overhead sign support pole was located 1.5 m (5.0 ft) north of the north road edge. The roadway surface composition was concrete in good condition and the posted speed limit was 105 km/h (65 mph). At the time of the crash, conditions were dawn, cloudy, and dry. The temperature at the nearest reporting station was 13.0° C (55.4° F), the wind speed was 12.8 km/h (8.0 mph), and the visibility was 16.0 km (10 mi). A crash diagram is included at the end of this report.

Figure 2. Overview of westbound approach

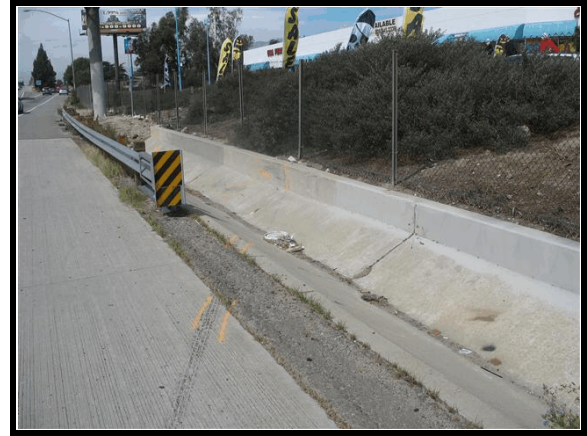
The Ford was traveling westbound in the second lane from the right of a five-lane roadway at a GPS-reported speed of 102 km/h (63 mph). The driver may have fallen asleep. The vehicle veered to the right and crossed the first travel lane. The driver braked as the Ford entered the right shoulder and departed the roadway (**Figure 3**).

Figure 3. Right roadway departure and impacts with guardrail and concrete drainage ditch (Events 1 and 2)

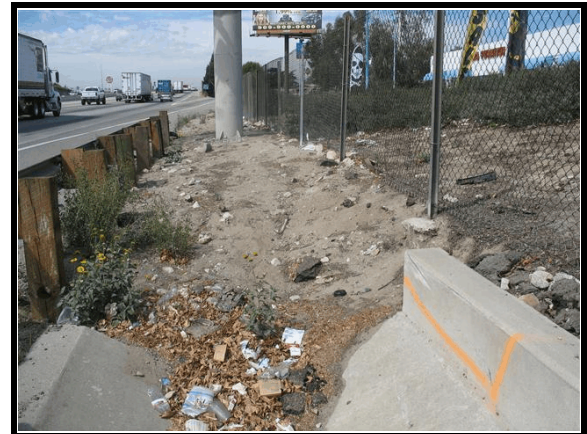
There were four events in this crash. After departing the roadway, the Ford impacted a guardrail (Event 1). The frontal air bags in the Ford probably deployed at this time. The Ford penetrated and overrode the guardrail as it continued traveling west and entered and impacted a concrete drainage ditch with its right front tire (Event 2). As the Ford traveled within the ditch it was redirected in a western orientation. The vehicle continued traveling west and right rear impacted an elevated portion of the ditch (Event 3). **Figure 4** shows the impact with the concrete ditch and the path toward the sign support pole. The Ford continued on and impacted a freeway overhead sign support pole with its front end (Event 4). The pole sustained minor cosmetic damage and was later repainted. Based on the final damaged appearance of the vehicle, the barrier algorithm of the WinSMASH program computed a Total Delta-V of 84.0 km/h (52.0 mph). The longitudinal and lateral components were -84.0 km/h (-52.0 mph) and 0 km/h, respectively.

Figure 4. Impact with concrete ditch (Event 3) and path to impact with support pole (Event 4)

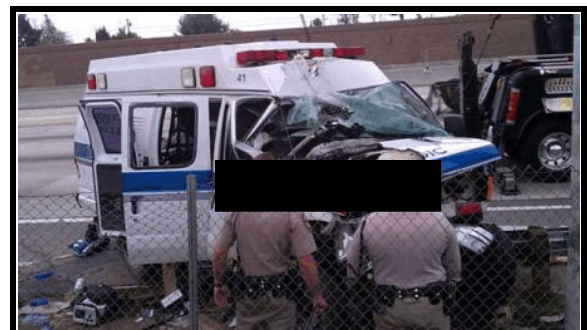
The Ford came to rest facing northwest (**Figure 5**). A portion of the guardrail bent outward into the travel lane. Several witnesses responded to the crash. They first helped the driver exit the vehicle.

Figure 5. Vehicle final rest, internet photo

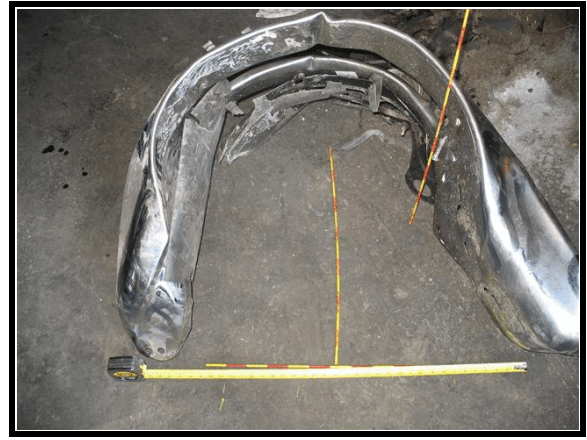
There were four events in this crash. The Ford sustained frontal damage from the impacts with the guardrail (Event 1) and the pole (Event 4). The severe pole impact damage masked the guardrail damage. The direct damage from the pole began 20.0 cm (7.8 in) left of right front bumper corner and extended 64.0 cm (25.2 in) to the left. There was contact damage that extended vertically from the bumper to the fiberglass shell at the windshield header. The bumper was displaced from the vehicle. A stringline was extended from the left frame rail to the right frame rail. Six crush measurements were documented along the stringline as follows: $C_1 = 40.0$ cm (15.7 in), $C_2 = 45.0$ cm (17.7 in), $C_3 = 54.0$ cm (21.2 in), $C_4 = 64.0$ cm (25.2 in), $C_5 = 71.0$ cm (27.9 in), $C_6 = 83.0$ cm (32.7 in). The displaced bumper was located and a crush profile was generated by measuring along the bumper face and comparing the bumper attachment points with the frame rails (**Figure 6**). The resulting crush profile was as follows: $C_1 = 42.0$ cm (16.5 in), $C_2 = 57.0$ cm (22.4 in), $C_3 = 114.0$ cm (44.9 in), $C_4 = 114.0$ cm (44.8 in), $C_5 = 110.0$ cm (43.3 in), $C_6 = 44.0$ cm (17.3 in). The Collision Deformation Classification (CDC) for the frontal impact with the pole was 12FZAW7.

Figure 6. Bumper crush profile

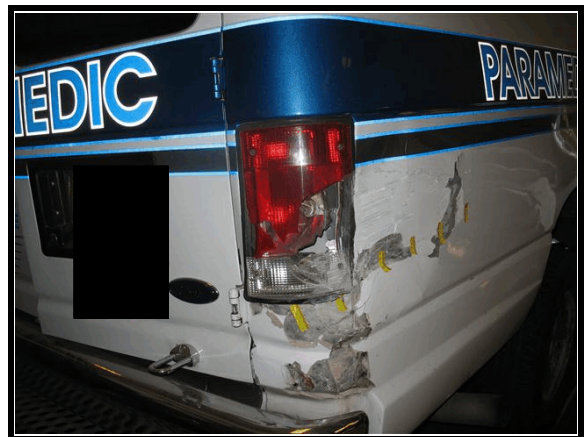
The vehicle sustained minor right side damage from impact with the concrete drainage ditch (**Figure 7**). The direct damage began 99.0 cm (38.9 in) rear of the rear axle and extended 54.0 cm (21.2 in) forward. The damage was located 107.0 cm (42.1 in) above the ground and measured 43.0 cm (16.9 in) in height. Six crush measurements were documented along the right side as follows: $C_1 = 6.0$ cm (2.4 in), $C_2 = 3.0$ cm (1.2 in), $C_3 = 2.0$ cm (0.8 in), $C_4 = 1.0$ cm (0.4 in), $C_5 = 1.0$ cm (0.4 in), $C_6 = 0$ cm. The CDC for this impact was 12RBES2.

Figure 7. Right side damage

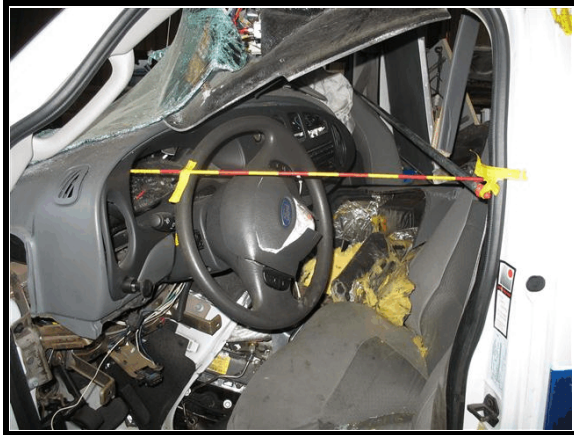
The top of the steering wheel rim was deformed 7.0 cm (2.8 in) forward (**Figure 8**) and there was shear capsule separation from occupant loading (**Figure 9**).

Figure 8. Steering wheel deformation

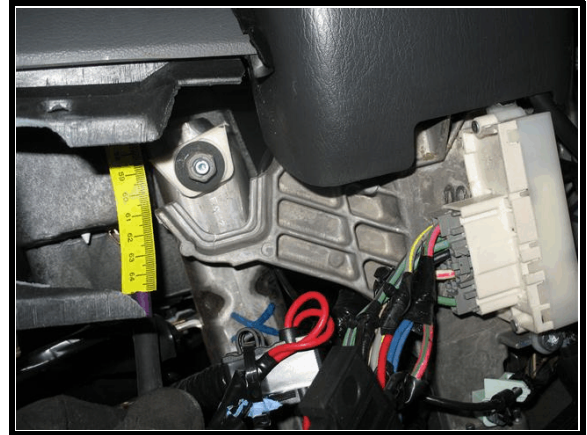
Figure 9. Left shear capsule separation

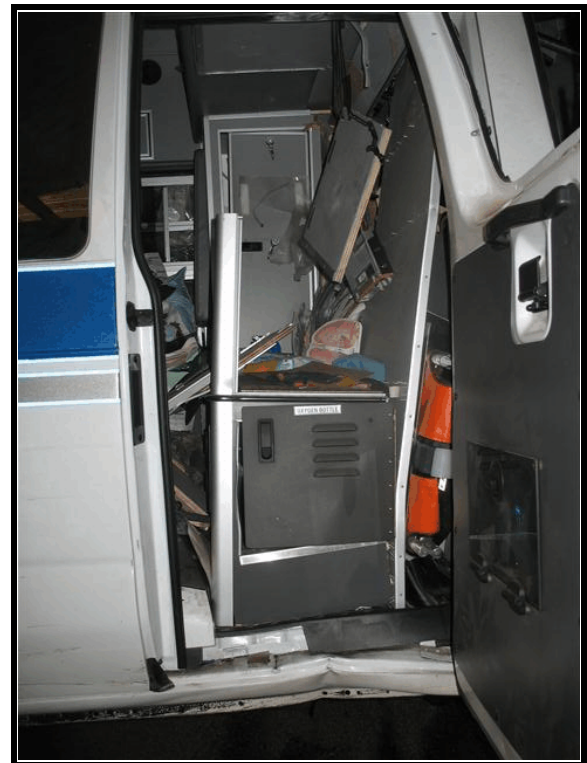
A wooden cabinet cluster was located at the front right of the ambulance interior. The cabinets and shelves located approximately 45.0 cm (17.7 in) above the floor were completely displaced and broken by Occupant 2 (**Figure 10**).

Figure 10. Side view of right front cabinetry

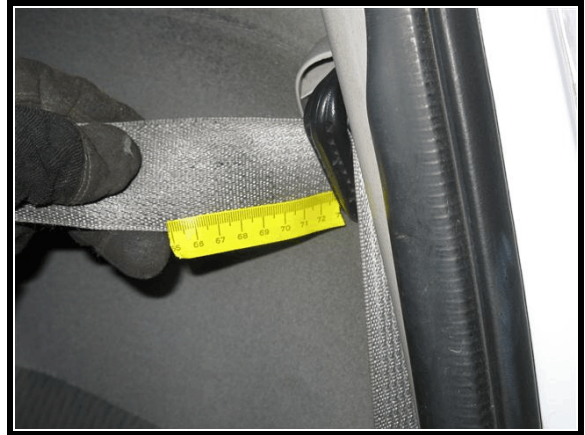
The Ford was configured with 3-point manual lap and shoulder belts for the front seat positions. The vehicle was equipped with driver and front right passenger safety belt retractor pretensioners; the driver's belt pretensioner actuated in the crash and the belt was locked in the spooled out position at the time of the vehicle inspection, and there was loading at the D-ring (**Figure 11**). The driver's safety belt anchorage adjustment was in the full-down position. The driver's safety belt was configured with a sliding latch plate.

Figure 11. Safety belt webbing load marks

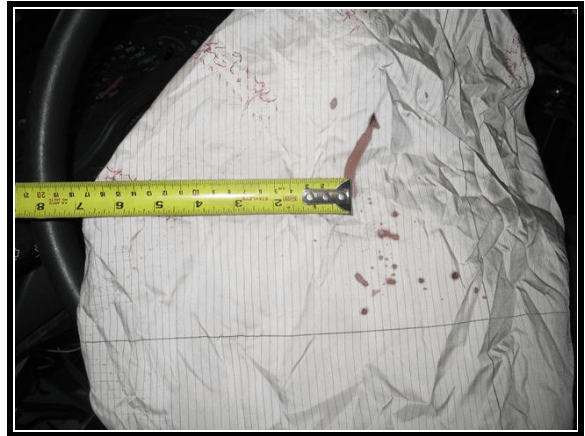
The driver's air bag deployed from the center of the steering wheel hub through H-configuration module flaps (**Figure 12**). The deployed air bag measured 47.0 cm (18.5 in) in width and 50.0 cm (19.7 in) in height in its deflated state. Two circular 3.0 cm (1.2 in) diameter vent ports were located at the 11 and 1 o'clock aspects on the rear panel. There were blood deposits documented on the upper quadrant of the air bag face. There was no damage to the air bag or module covers.

Figure 12. Driver's air bag

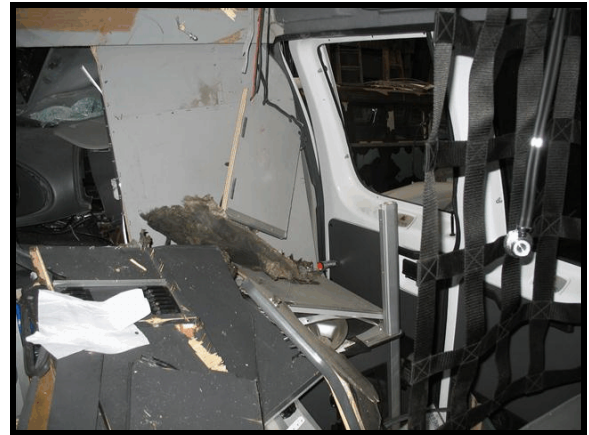
The 23-year-old male rear area occupant was lying on the Stryker ambulance cot. According to the driver, Occupant 2 was asleep, unrestrained, with his head toward the front of the ambulance and the cot at its lowest recline setting. At impact with the guardrail and the concrete culvert, he was displaced forward and to the right. He probably remained on the cot. At impact with the pole, he was displaced forward and impacted the cabinetry located primarily on the front right of the rear compartment (**Figure 13**). The damage was generally at the level of the ambulance cot. This occupant sustained skull, rib and spinal fractures from contact to the cabinet. He also sustained brain and lung injuries, as well as multiple contusions, abrasions, and lacerations. This occupant was covered in debris post-crash. He was found lying down, facing the side door, curled up in a fetal position. He was transported to a local hospital and was declared deceased at approximately 0907 hours (two hours post-crash).

Figure 13. Right front cabinetry
